Water Compliance Inspection Report

Reconnaissance Inspection

Genwal Resources, Inc.
Crandall Canyon Mine

UPDES Permit Number (UT0024368)

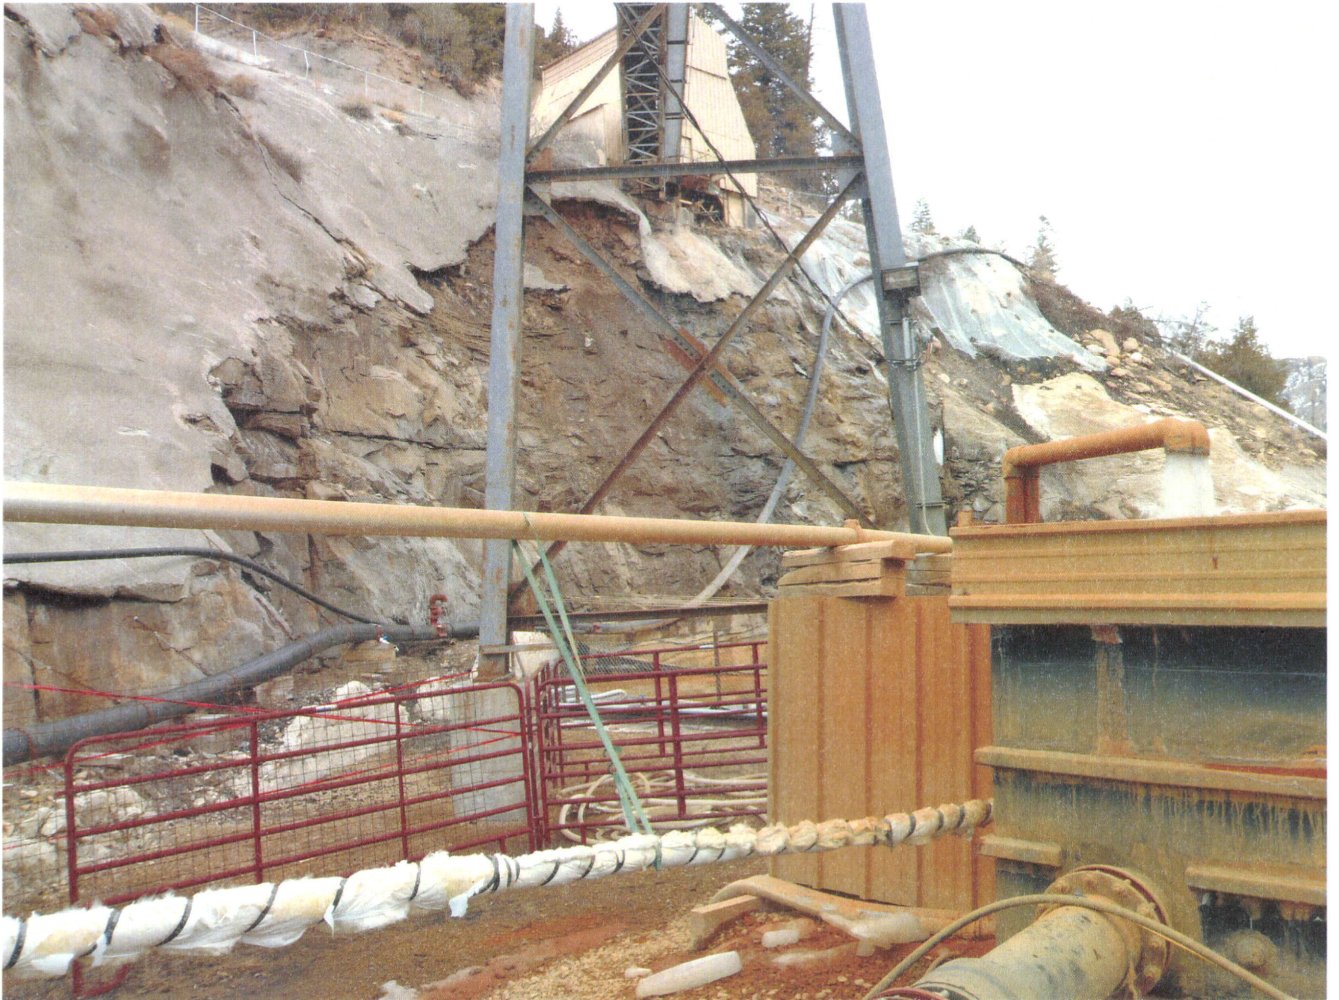
The mine had experienced a land slide which broke the line running from the mine to the iron treatment system. This happened on March 13, 2013 at 5:10 a.m. and at 9:00 a.m. the mine discharge had been shut down and repairs were being made. The untreated mine water running into the system was inadvertently routed to the pond associated with Outfall 001 as a result of water capture systems installed to prevent runoff water from leaving the disturbed area. A picture showing this system will be included at the end of

Photo #1: Shows where the rock slide occurred. The black line coming down the rock face was cut lose from the wall and torn at the top of the ledge.

1. Please submit a write up of the incident to include time frames of when the mine became aware of the slide, how they became aware of it, and response times as well as notification times of the appropriate agencies.
2. Please indicate what modifications to the system can be made to prevent discharge of untreated mine water to waters of the State in case another slide of similar nature occurs again.

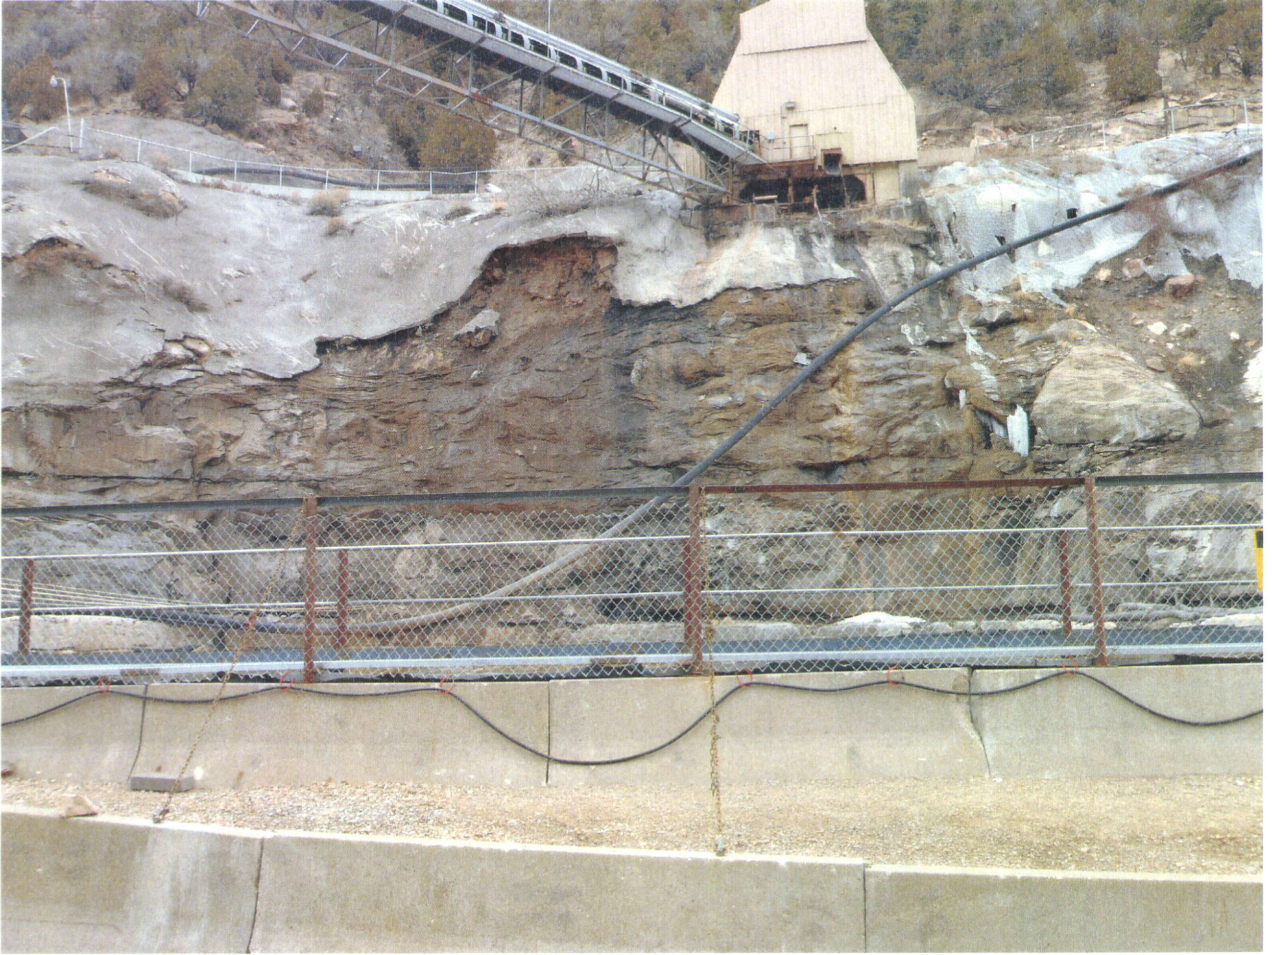
Photo #2: Another view of the rock slide area.

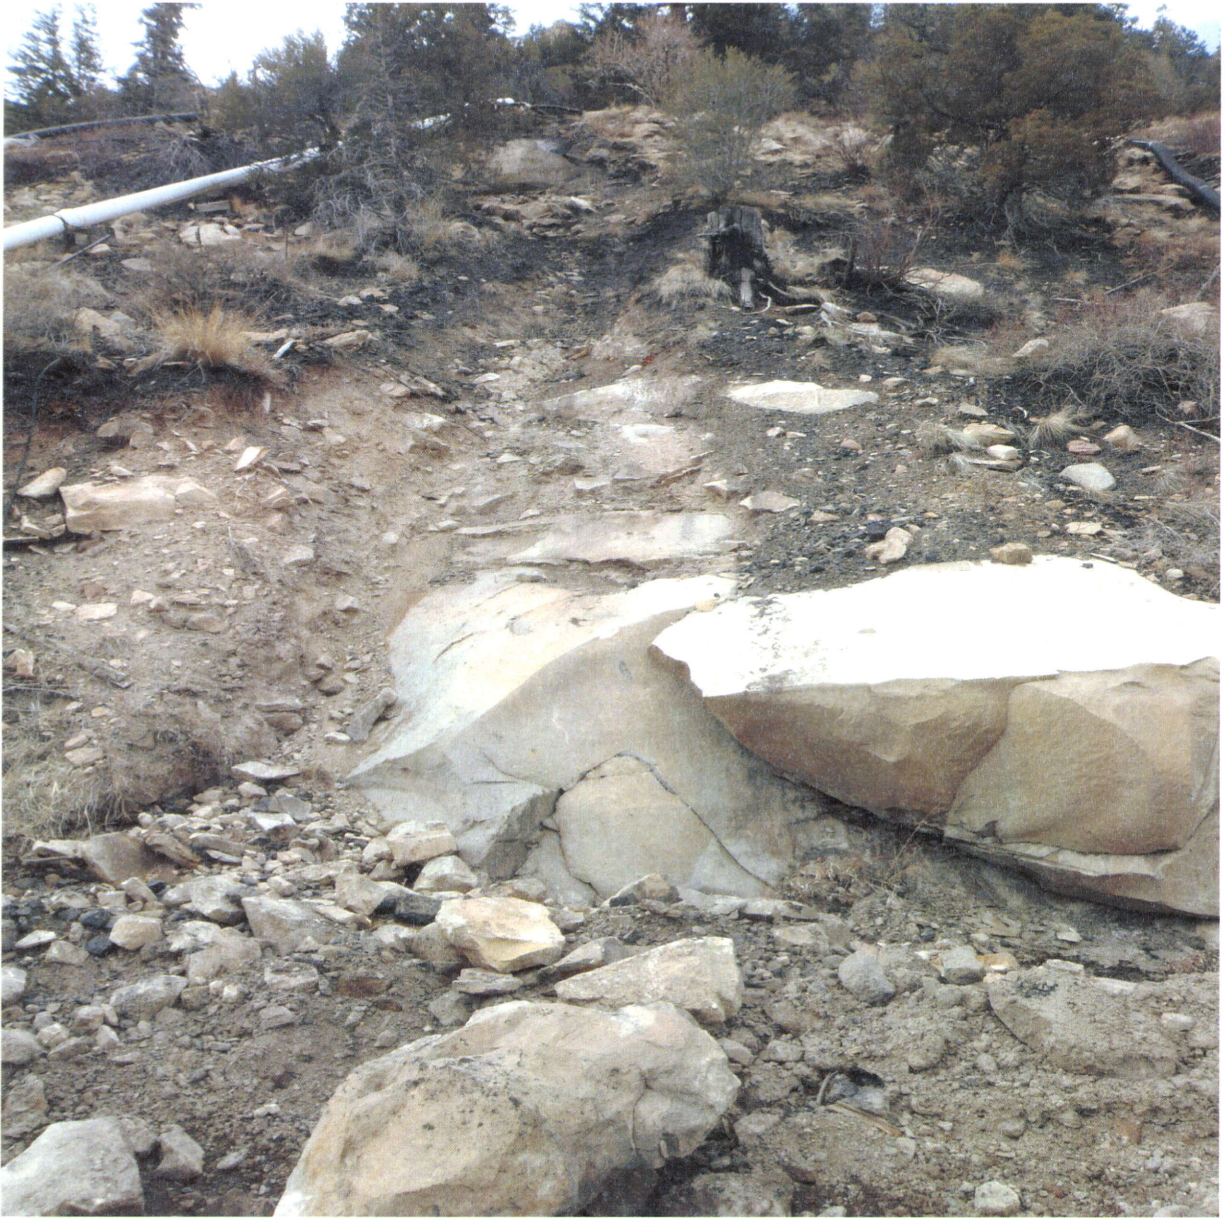
Photo#3: Where the water from the broken black pipe (visible at top left) came down the hill.

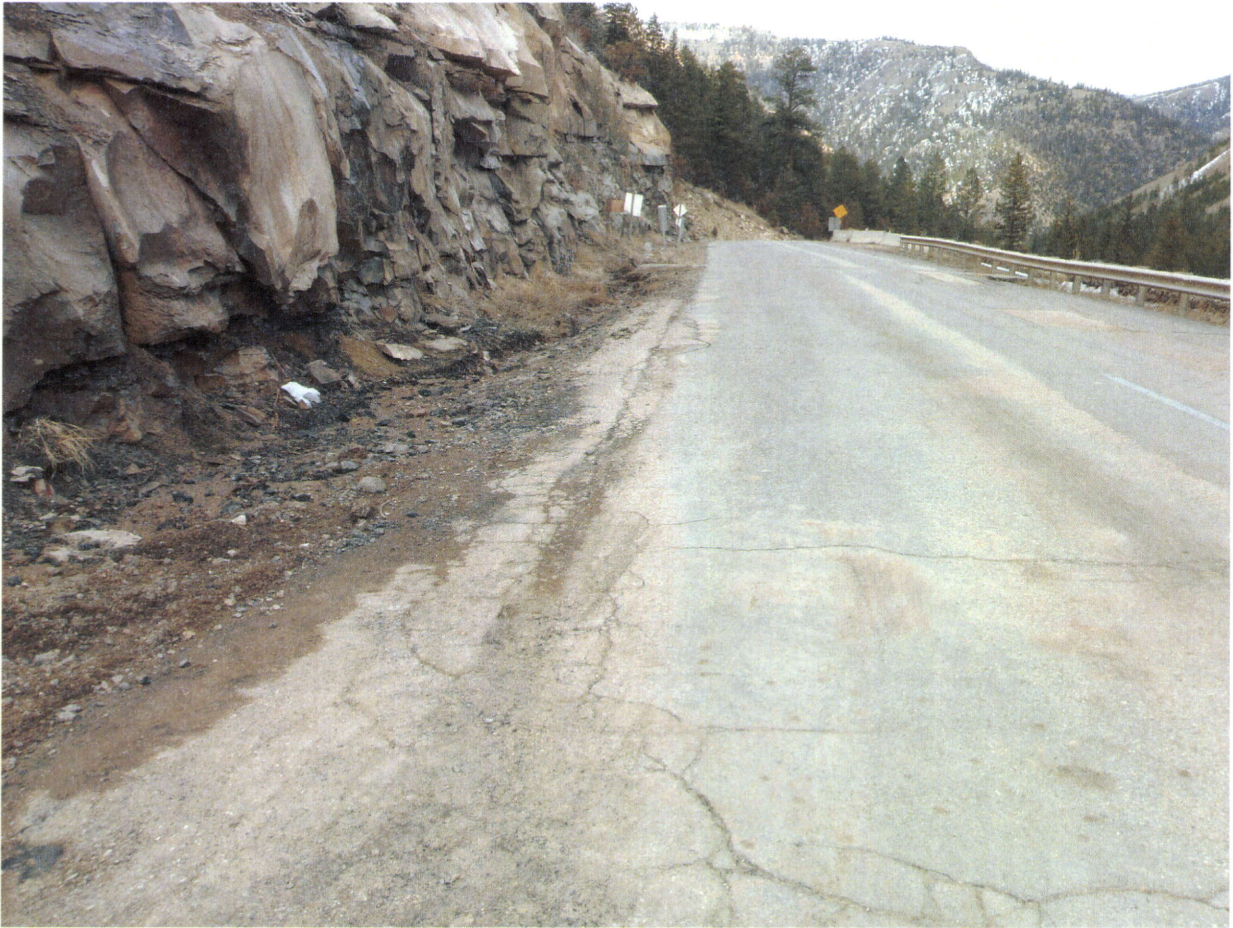
Photo #4: Water flowed on the ditch on the side of the road to about the first white sign on the left, then went under the road through a pipe to pond 001 where none was discharged to Crandell Creek.

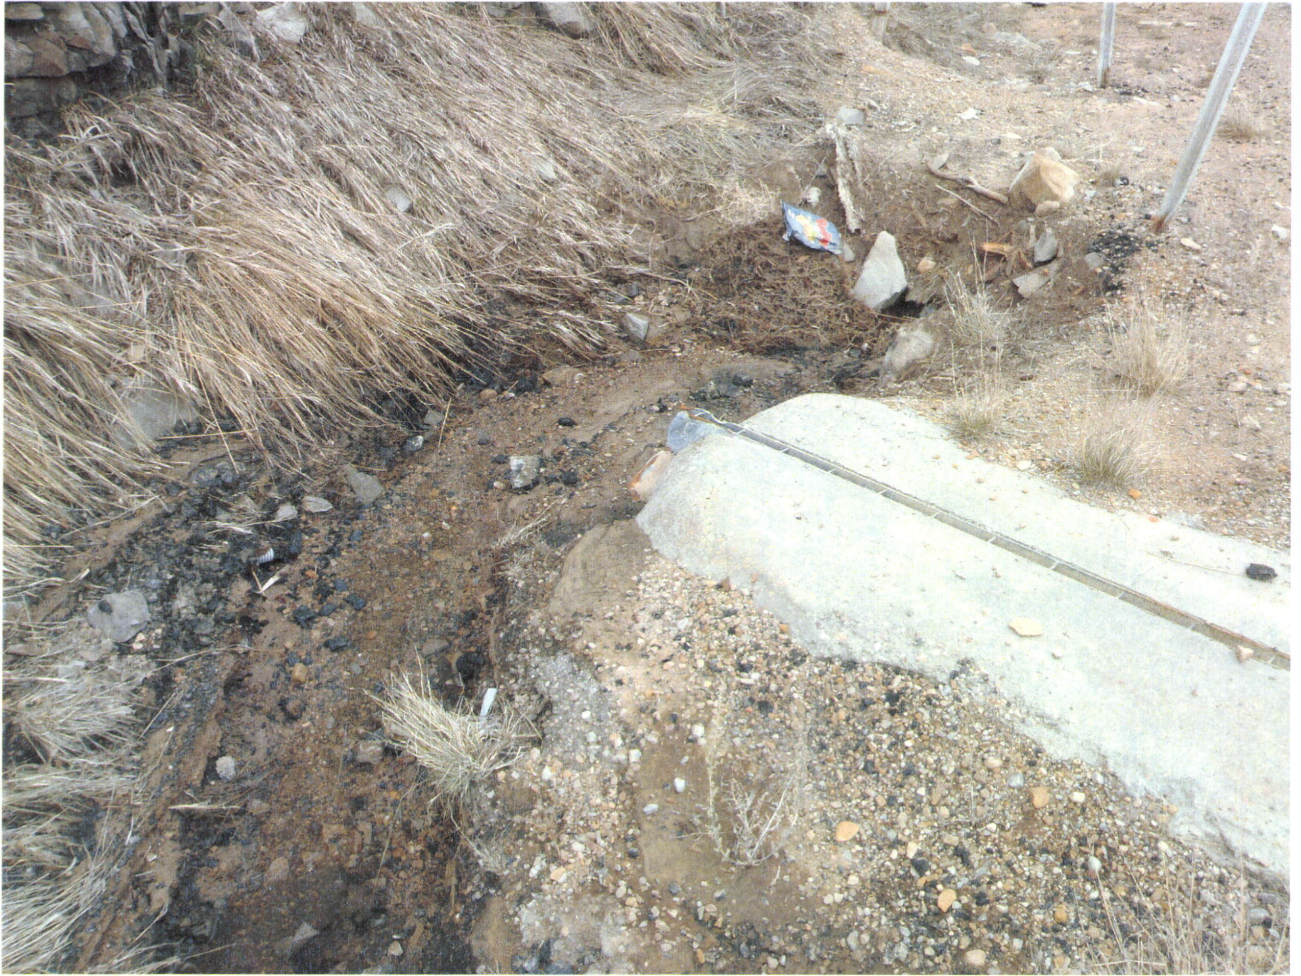
Photo #5: Pipe crossing the road going into pond 001. Note the grating in the pipe. This is continued in the road to make sure any runoff coming down the road is caught in the pipe and shunted to the drainage pond 001. The grating is around one to two inches in size and should capture a decent amount of flow running down the road.

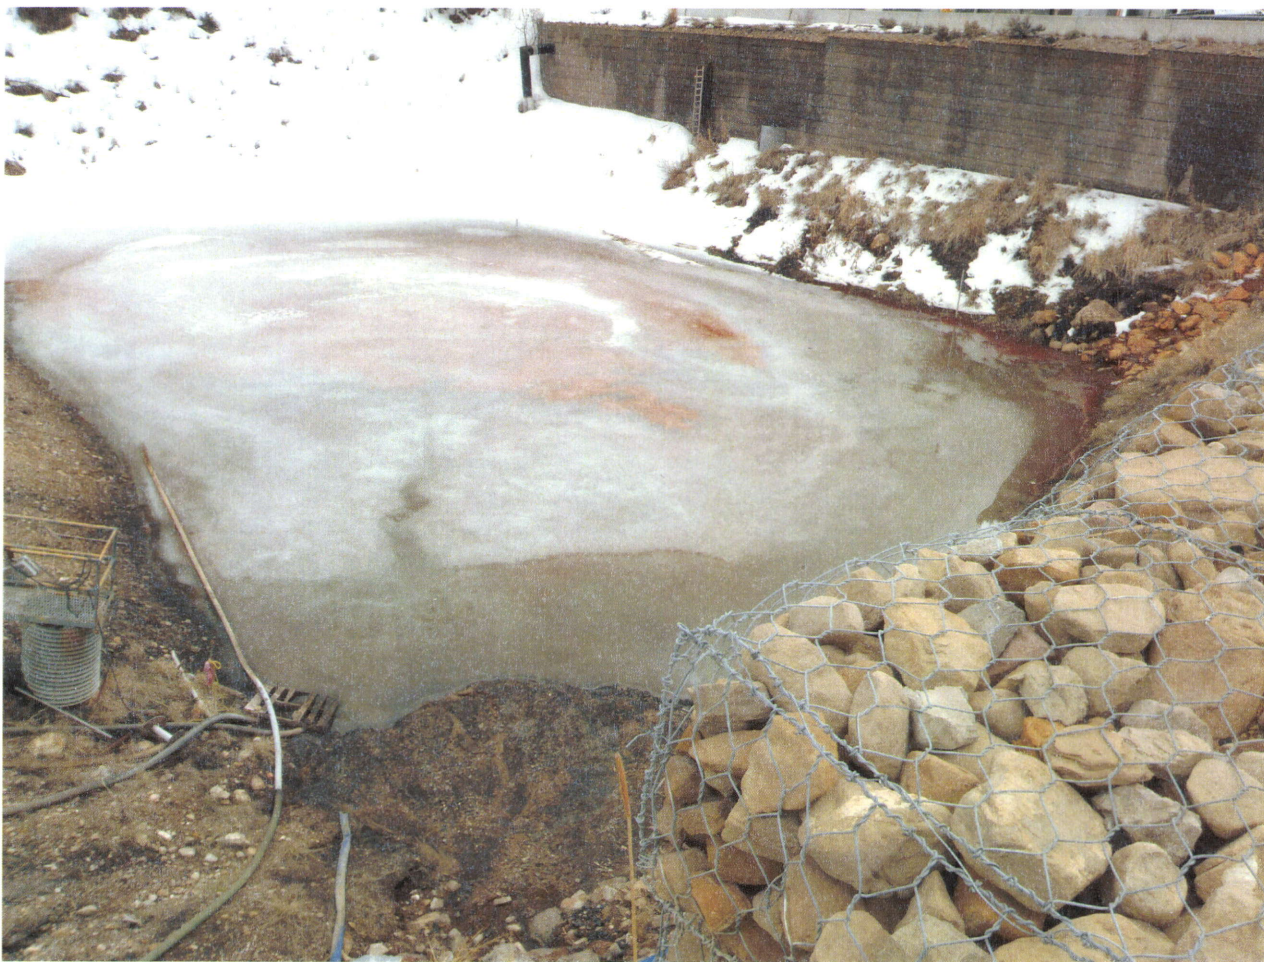
Photo #6: Pond associated with Outfall 001, where the untreated mine water ended up.
